BEKER INDUSTRIES CORP.

Subject: PRODUCT LOSS FROM NO. 3 GYPSUM POND

Subject: GYP POND DIKE FAILURE

LOG OF EVENTS REGARDING GYP POND DIKE FAILURE

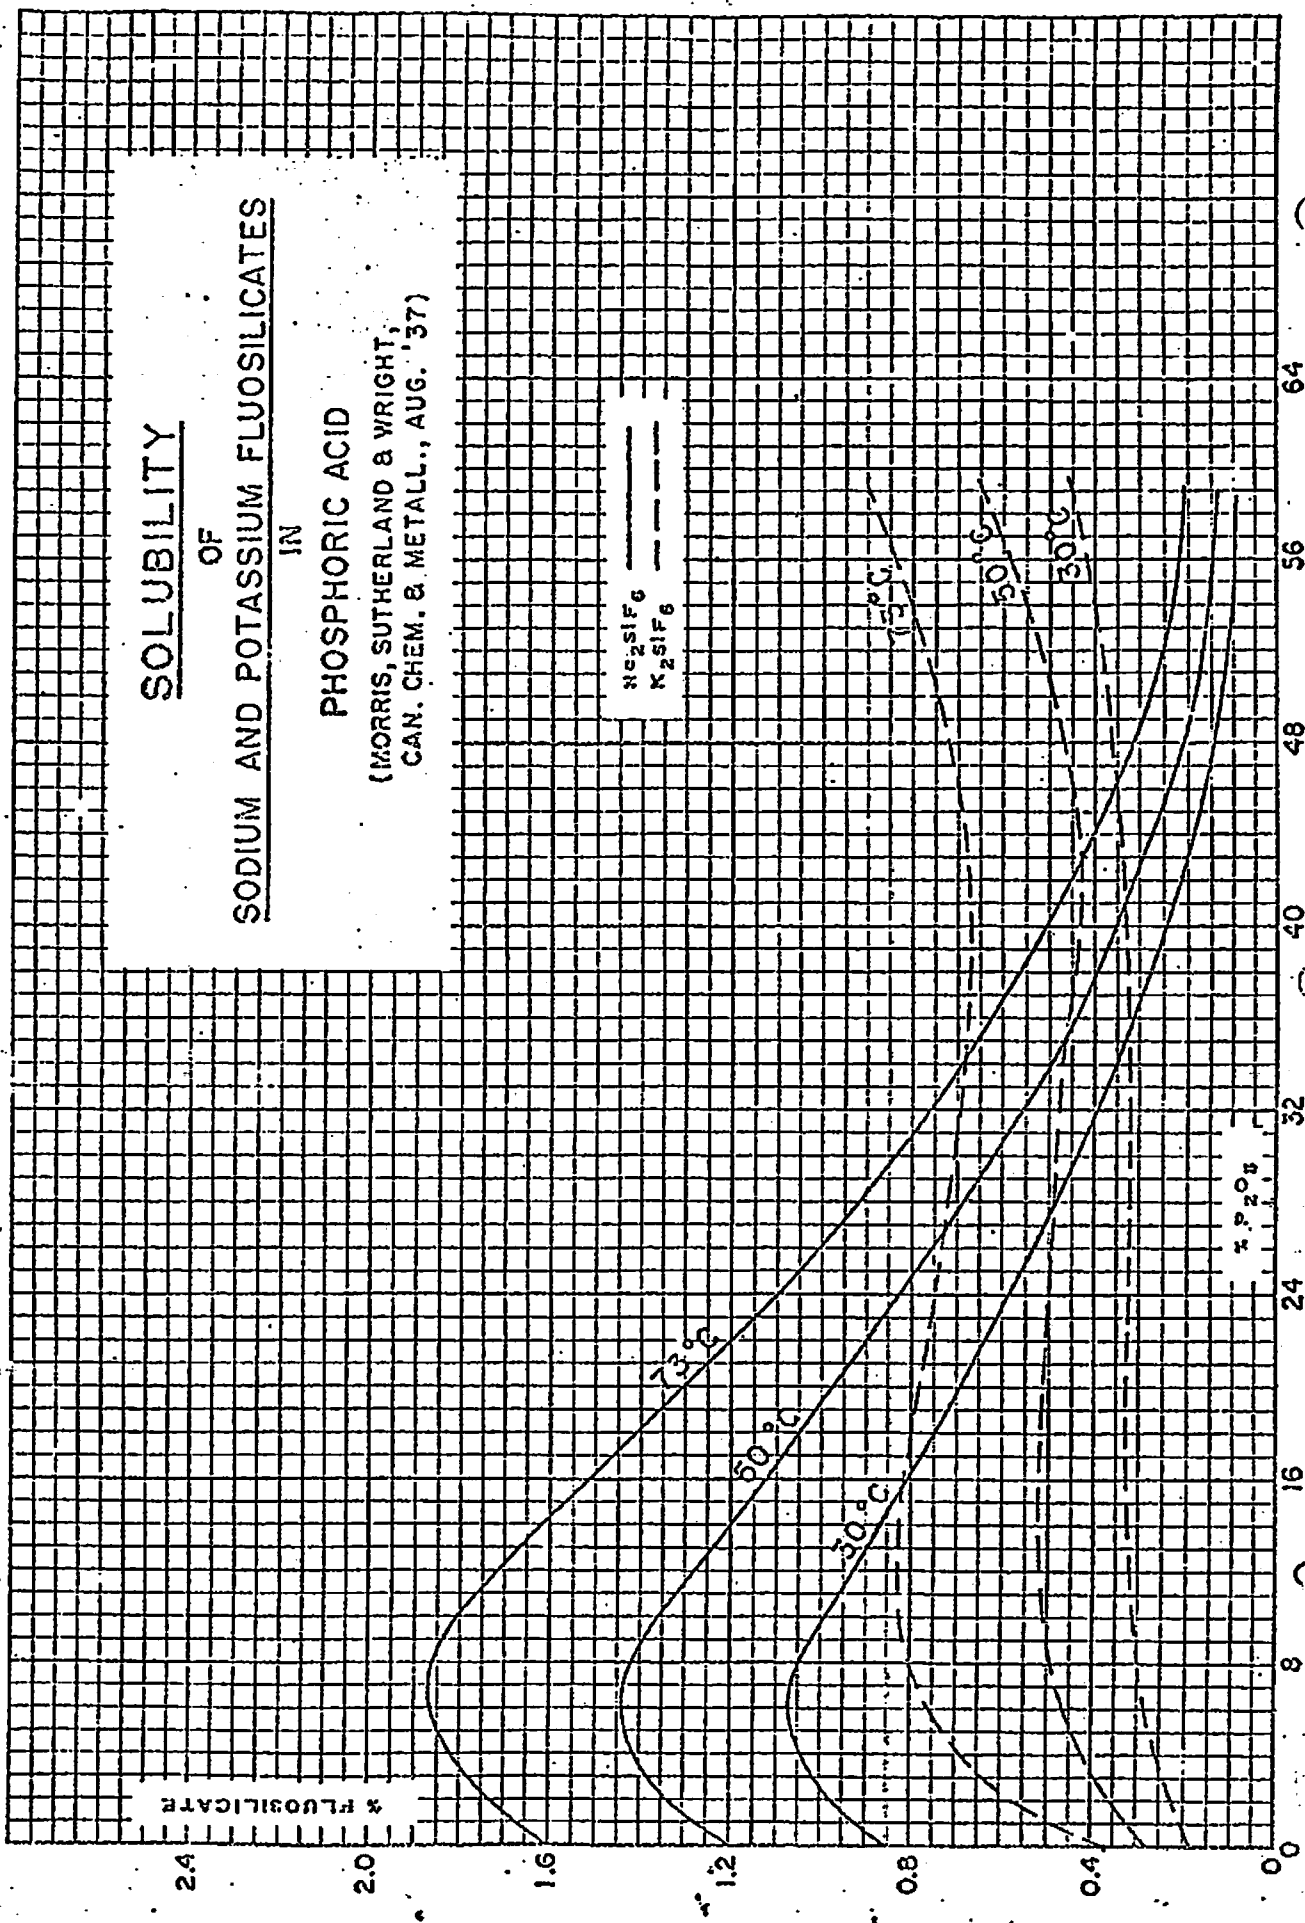
Figure 3

cooling process, the solubility of sodium fluosilicate drops from 1.3% to 0.7%. The solubility of potassium fluosilicate drops from 0.6% to 0.4% (See Figure 3). This loss of diluents would result in a 0.8% upgrading of the P_2O_5 in solution. Even more upgrading would result from the normal evaporation rate in this area.

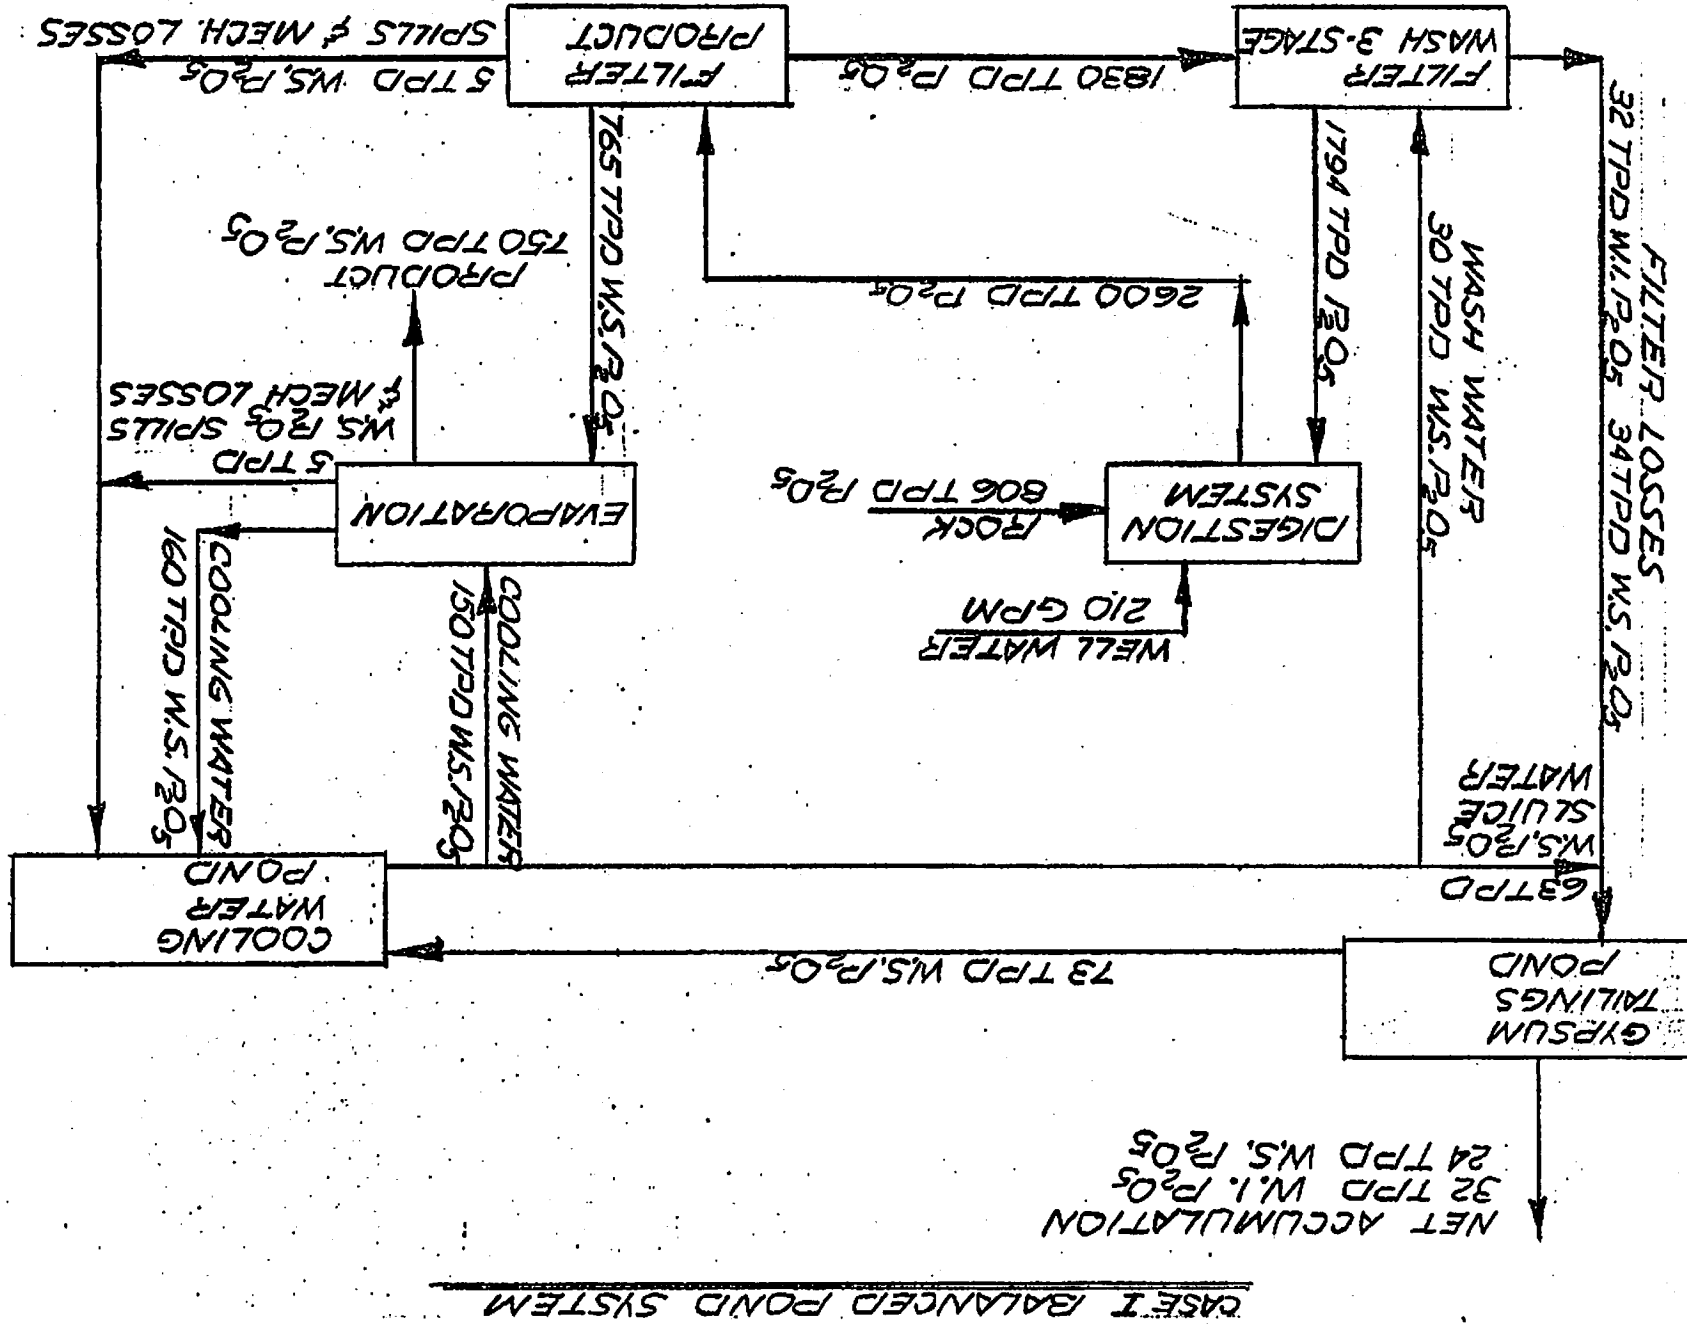
A P_2O_5 balance in the pond system is shown in Figures 6, 7, and 8. Figure 6 shows a balanced pond system with the phos acid plant operating at 93% total P_2O_5 recovery. Well water is added to the digester. All of the filter wash water comes from the cooling pond. Figure 7 shows the pond system while the #3 pond was filling up and the water could not be recovered. In this case the sluice water had to be raw water and the amount of wash water was somewhat reduced. Additional well water had to be added to the digestion system to balance the reaction. Figure 8 shows the system which is used when the pond level gets high. This is the system which would have been used to reclaim the pond water. In this system, very little well water is added to the digestion system. The P_2O_5 which is in the pond water added to the digester reports directly to the product stream and moves on to the evaporation step. This is not a hypothetical case. It has been used in the past to reduce pond levels. When this case is in practice, the actual plant recoveries are 94.9%.

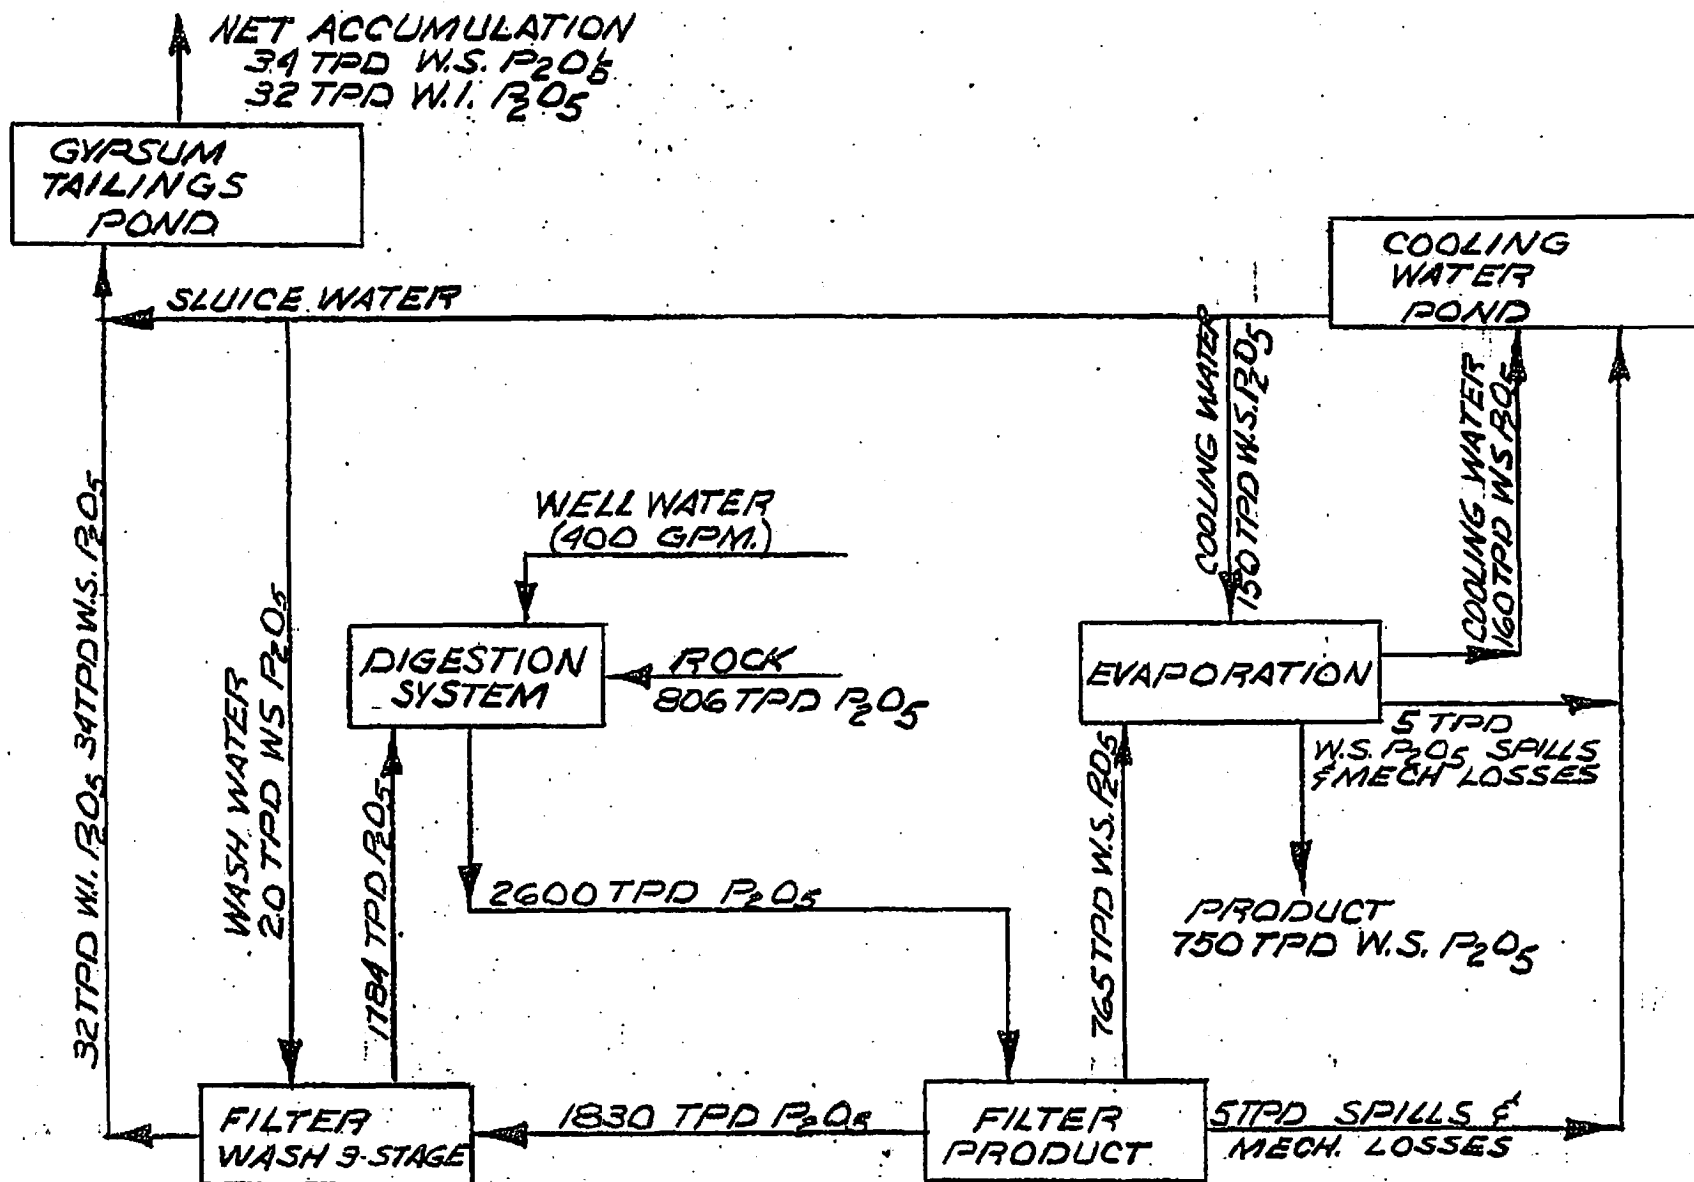
Figure 7

CASE II POND SYSTEM WHILE FILLING NO.3 POND

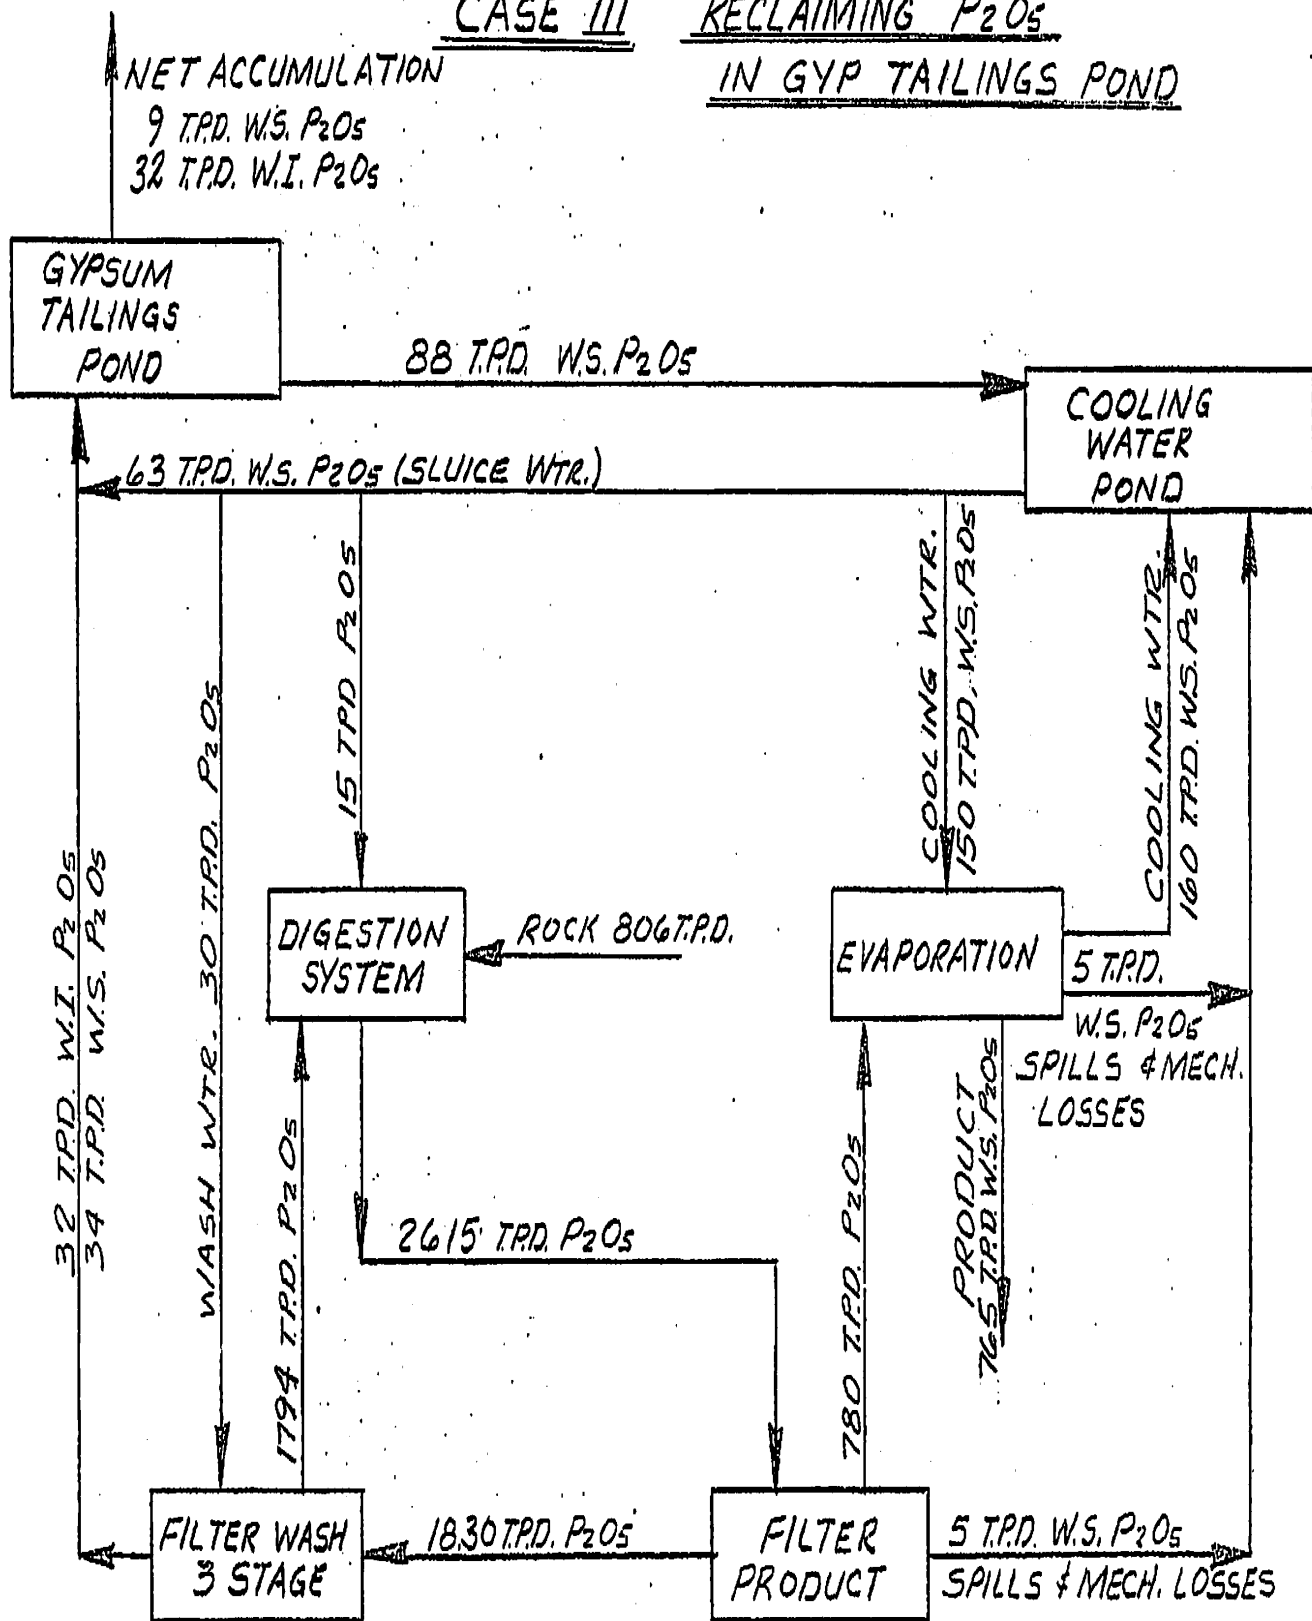
Figure 8

CASE III

RECLAIMING P_2O_5

IN GYP TAILINGS POND
